# MEASUREMENT OF MECHANICAL PROPERTIES IN SITU AND MODELING OF TIMBER STRUCTURES IN RUHNU CHURCHES (ESTONIA) DAMAGED BY WOOD-DESTROYING INSECTS

There are two churches in the Baltic Sea island of Ruhnu, the first wooden church was built in 1642 – being the oldest wooden heritage building of Estonia – and the second, a stone church, established in 1912.

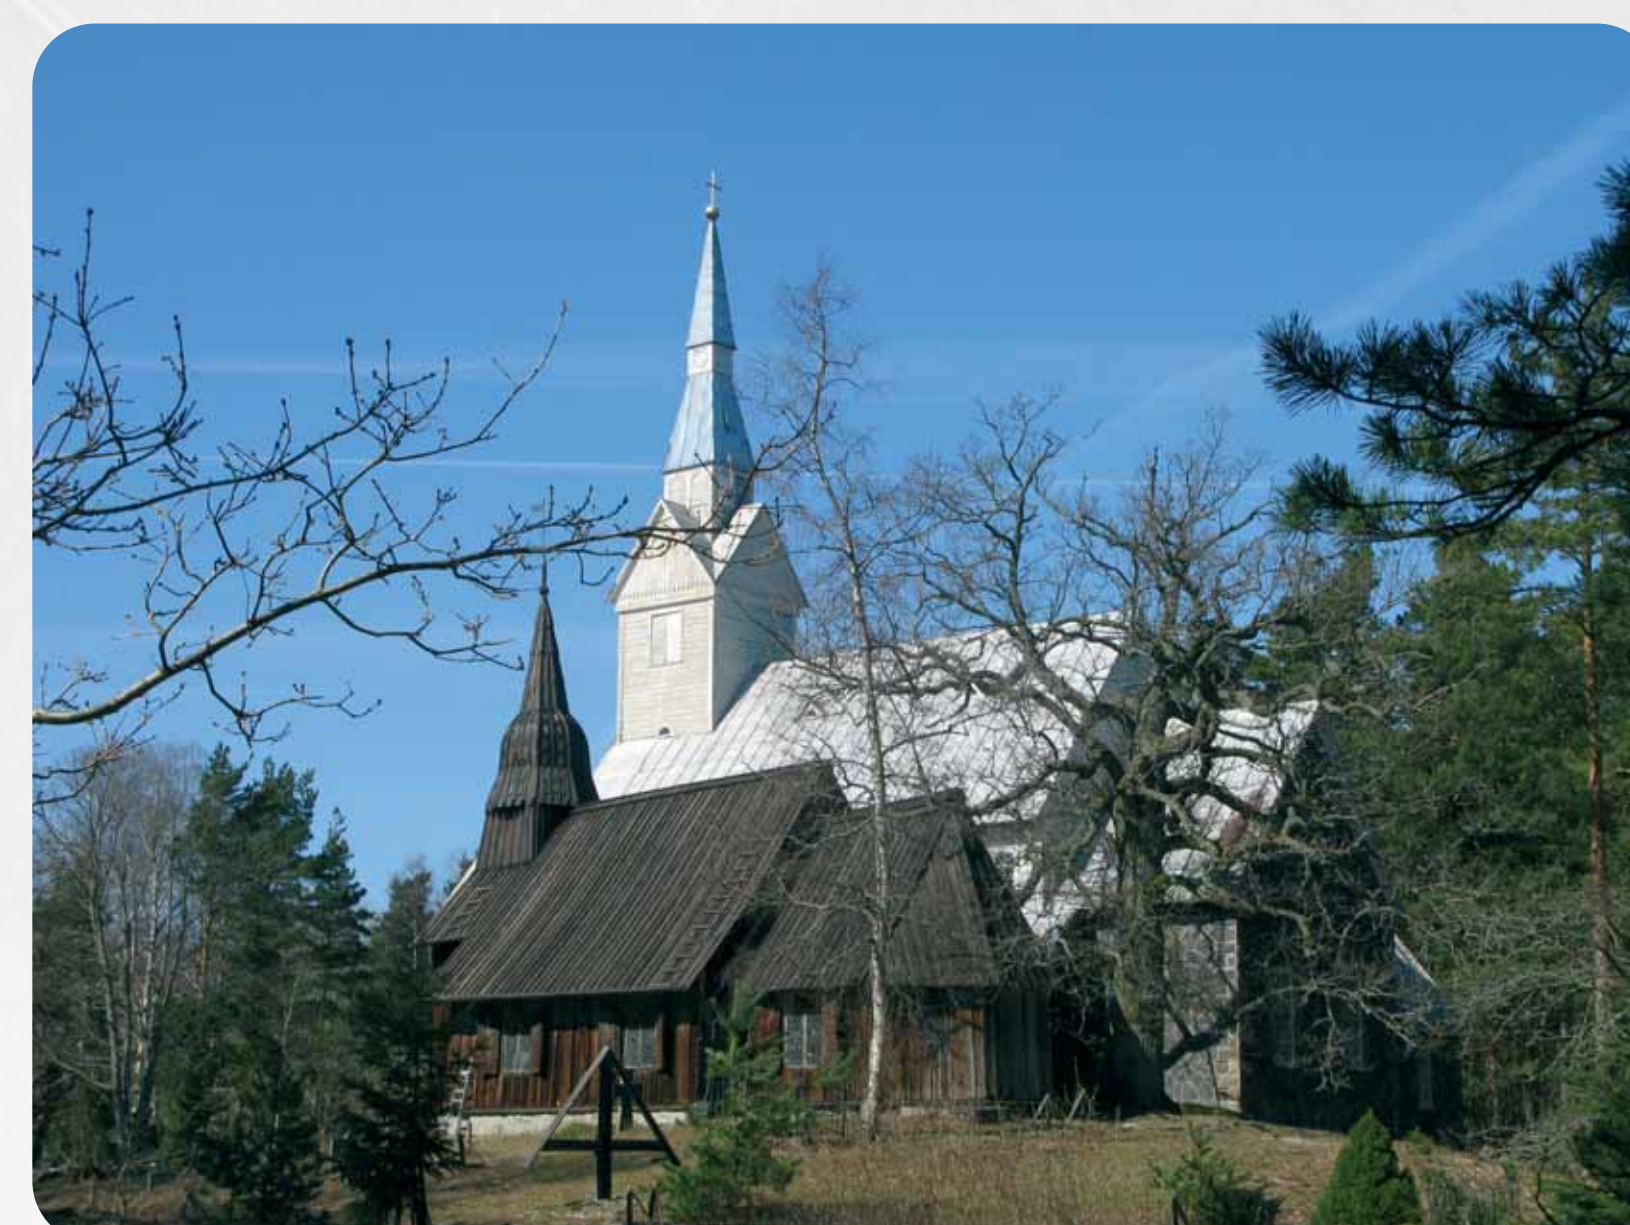
Fig.1. Old wooden church and new stone church

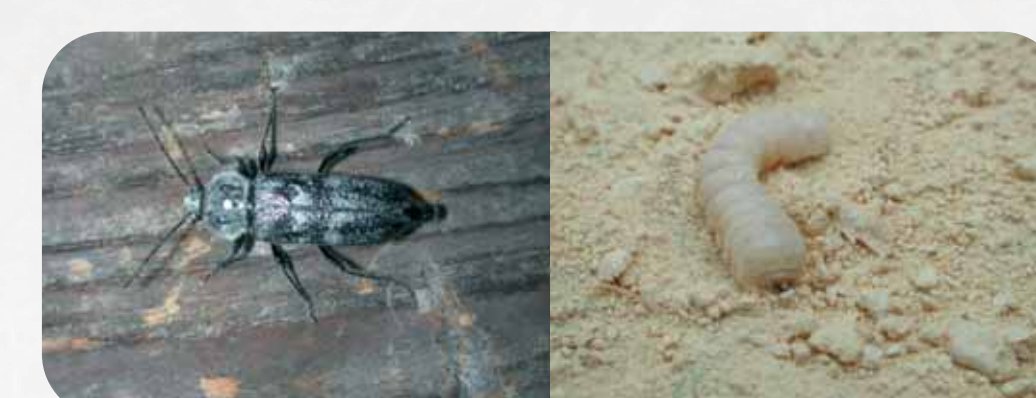
Almost all wooden parts in the new **Maarja Magdaleena church** (Fig.1) on Ruhnu Island are intensively damaged by the House longhorn beetles (*Hylotrupes bajulus* (L.)) (Fig.2). The wooden benches, pillars, stairs, and walls show characters of former – yet more important also on-going active – attack. The most intensive characters of attack are found in the structures of the stone church steeple (Fig.3) and in the roof construction.

Fig.2. House longhorn beetle (female beetle and larva)

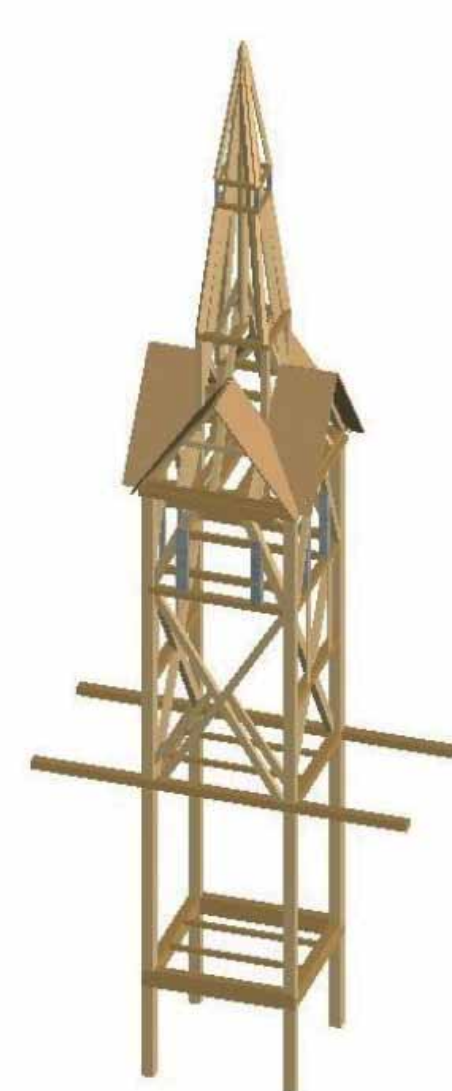
Fig.4. Axonometrics view of steeple timber structures

The beams of the supporting structures were modelled (Fig.4), whereas the joints were neither modelled nor calculated (Fig.5). In the modelling of beams, the worst possible option was chosen, that is, the smallest cross-section found was used as the reference cross-section for the beams. In the modelling of the steeple, exterior panelling giving extra strength to the steeple was not taken into account.

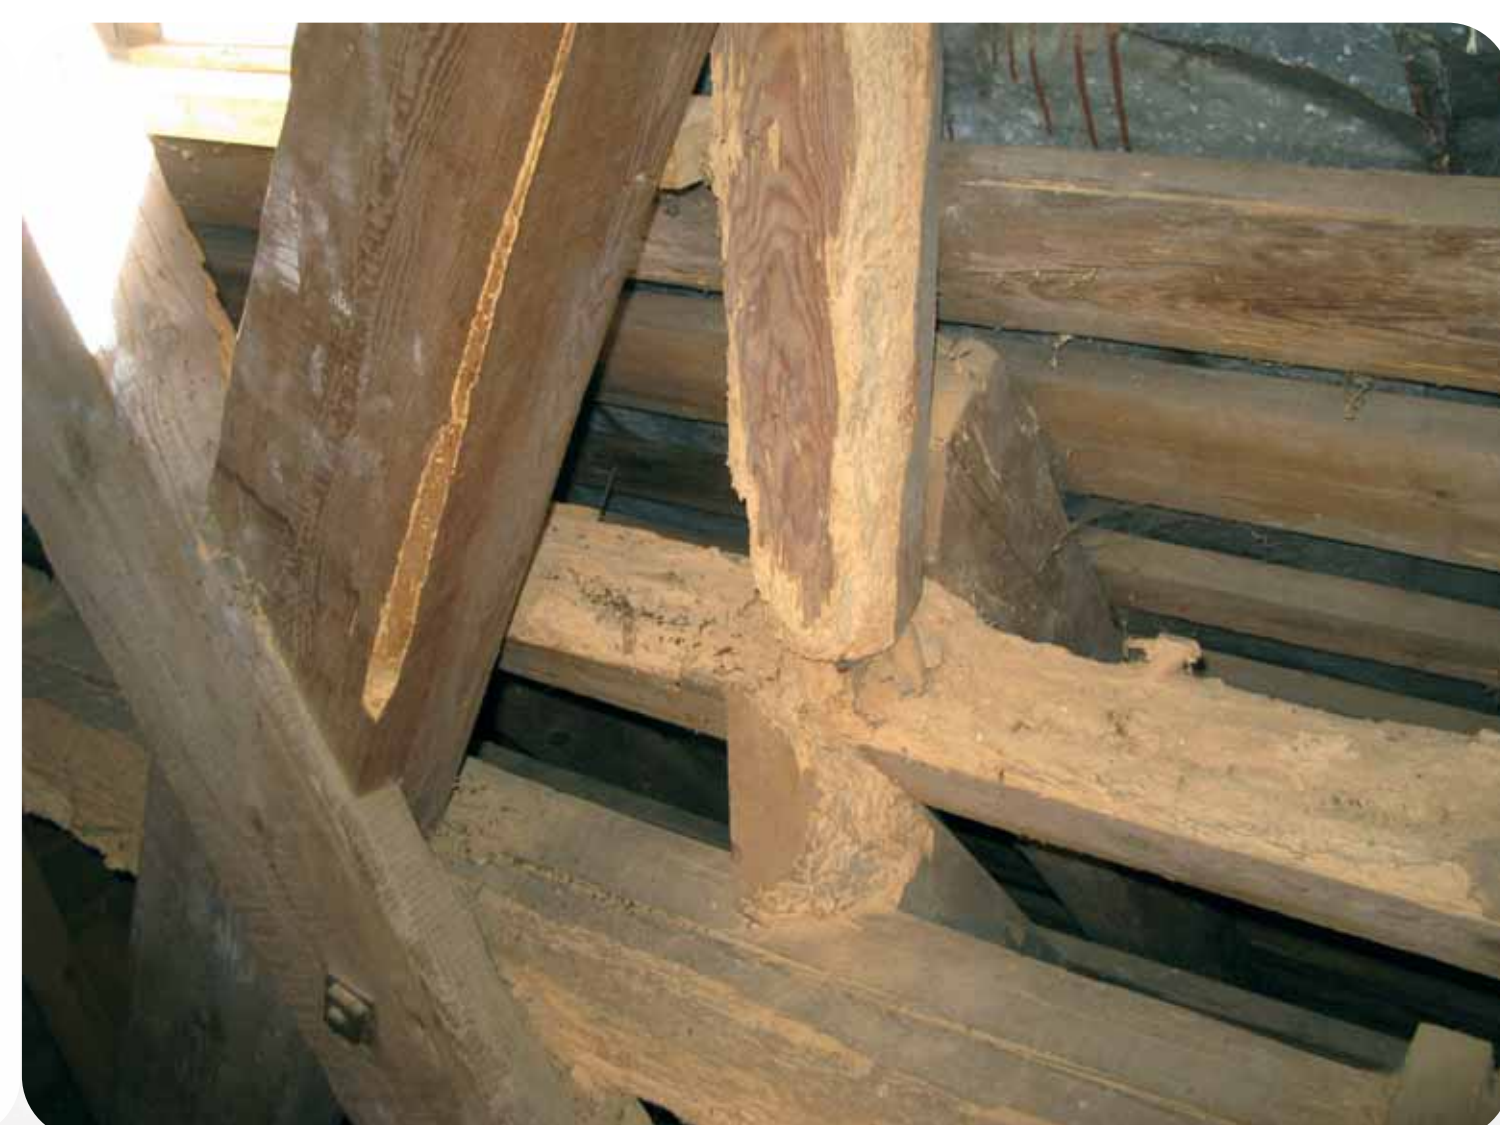
Fig.5. Steeple joints

Proposed steeple restoration activities include the suspension of beetle attacks (general treatment of the timber structures of the church), reinforcing steeple members and making additional calculations for testing the strength of joints.
