INTERNATIONAL BIODETERIORATION & BIODEGRADATION

2nd International Conference on Biodeterioration of Wood and Wood Products,
Tartu, Estonia

In-situ measurement of microclimatic conditions and modeling of mechanical properties of timber structures – A case study on new church on Ruhnu Island, Estonia

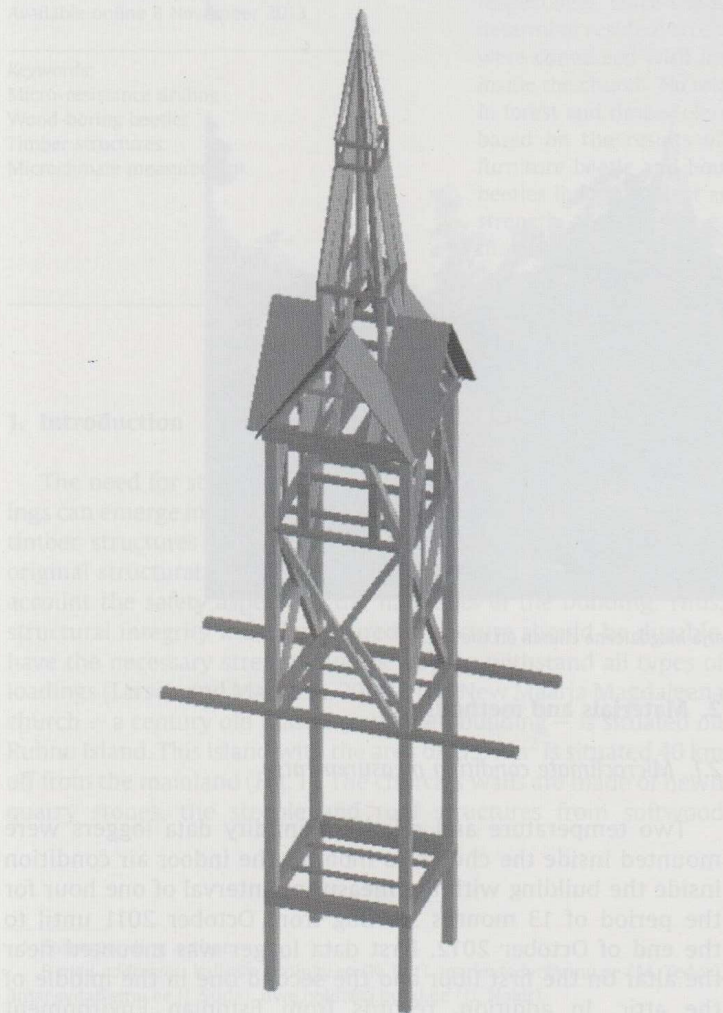
Fig. 3. Axonometric view of steeple timber structures of the New Maarja Magdaleena church.

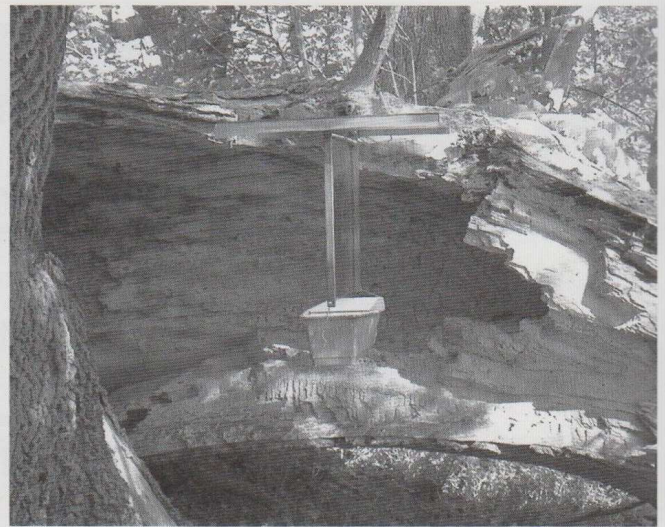
Fig. 4. The trunk-window trap.

The survey of abundance of saproxylic beetles was conducted on Ruhnu Island from May to August in 2011 and 2012. 33 trunk-window traps were used during those two years to survey the flight-active beetle fauna. The following variables where the trap was placed were measured: the location (geographical coordinates), description of surroundings, distance to the closest building, and amount of dead wood on the tree. The trap consisted of film panel with the dimensions of 55 by 45 cm, and a rectangle-shaped collecting vessel of plastics with the dimensions of 55 by 15...20 cm and with the deepness of 13 cm (Fig. 4). Timber-framed trap was fixed by a metal rod to the tree trunk about 1.3 m above

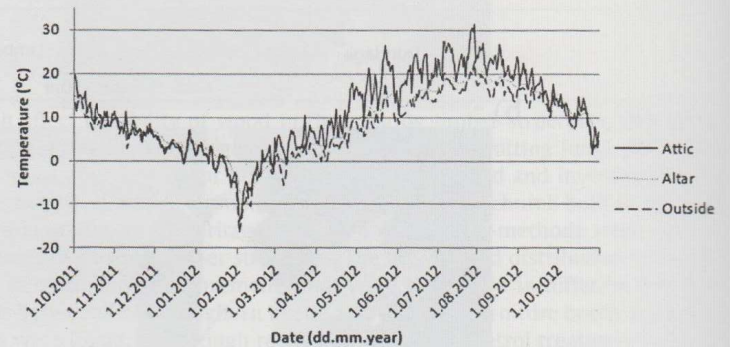
Fig. 5. Daily measurements of air temperature inside and outside the church for a period of 14 months starting from September 2011 until October 2012.

The results of visual inspection revealed that the steeple was mainly damaged by house longhorn beetles. Within the whole church the damages were more serious mainly in the southern side. Indoor microclimate and outdoor climate measurements were compared (Figs. 5 and 6). Generally, the fluctuation between the indoor and outdoor temperature in winter is small, meaning that the church was not heated during the measured time. As the weather in summer time is warm, the temperature is higher and relative humidity lower which is caused by a normal physical performance in building envelope in the attic. Earlier studies show that stridulation sound frequency of house longhorn beetle in 30 °C is 1.82 times higher than in 20 °C (Breiobach, 1986). Due to this finding the boring activity in the southern side is higher than in the northern side of the church. Lethal upper temperature for larvae of common furniture beetle is 48 °C and for larvae of house longhorn beetle is 55 °C (Hansen and Vagn Jensen, 1996). According to the Figs. 5 and 6 the temperatures were higher in the attic (in summer time mostly over 20 °C) and no upper lethal temperatures were measured. Therefore, in future researches, measurements of microclimate conditions should be conducted in different locations of cardinal points.

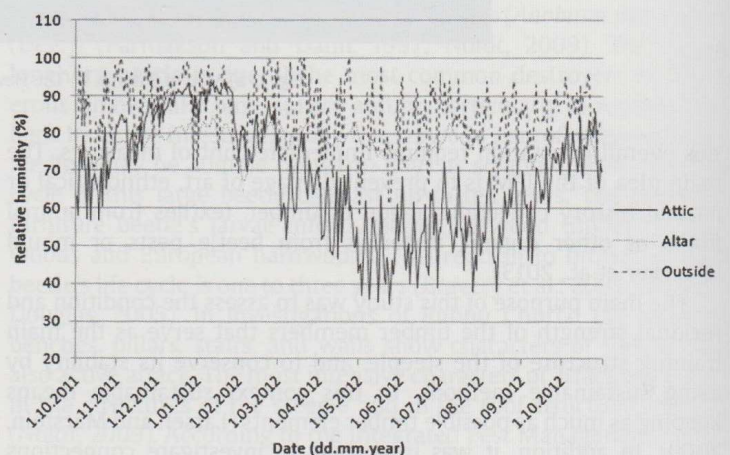
Fig. 6. Daily measurements of relative humidity inside and outside the church for a period of 14 months starting from September 2011 until October 2012.
