Coastal lagoons in Estonia and in the Central Baltic Sea region

Development history, geology and hydrology, biodiversity and
nature conservation value

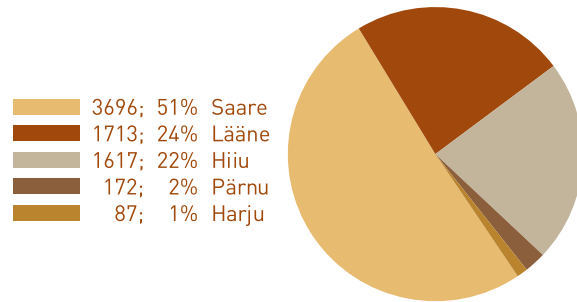
Figure 1.2.1. Distribution of coastal lagoons by counties, based on their surface area. The numerical data presented on the figure reflect the area on hectares and the share of the total area in per cents.

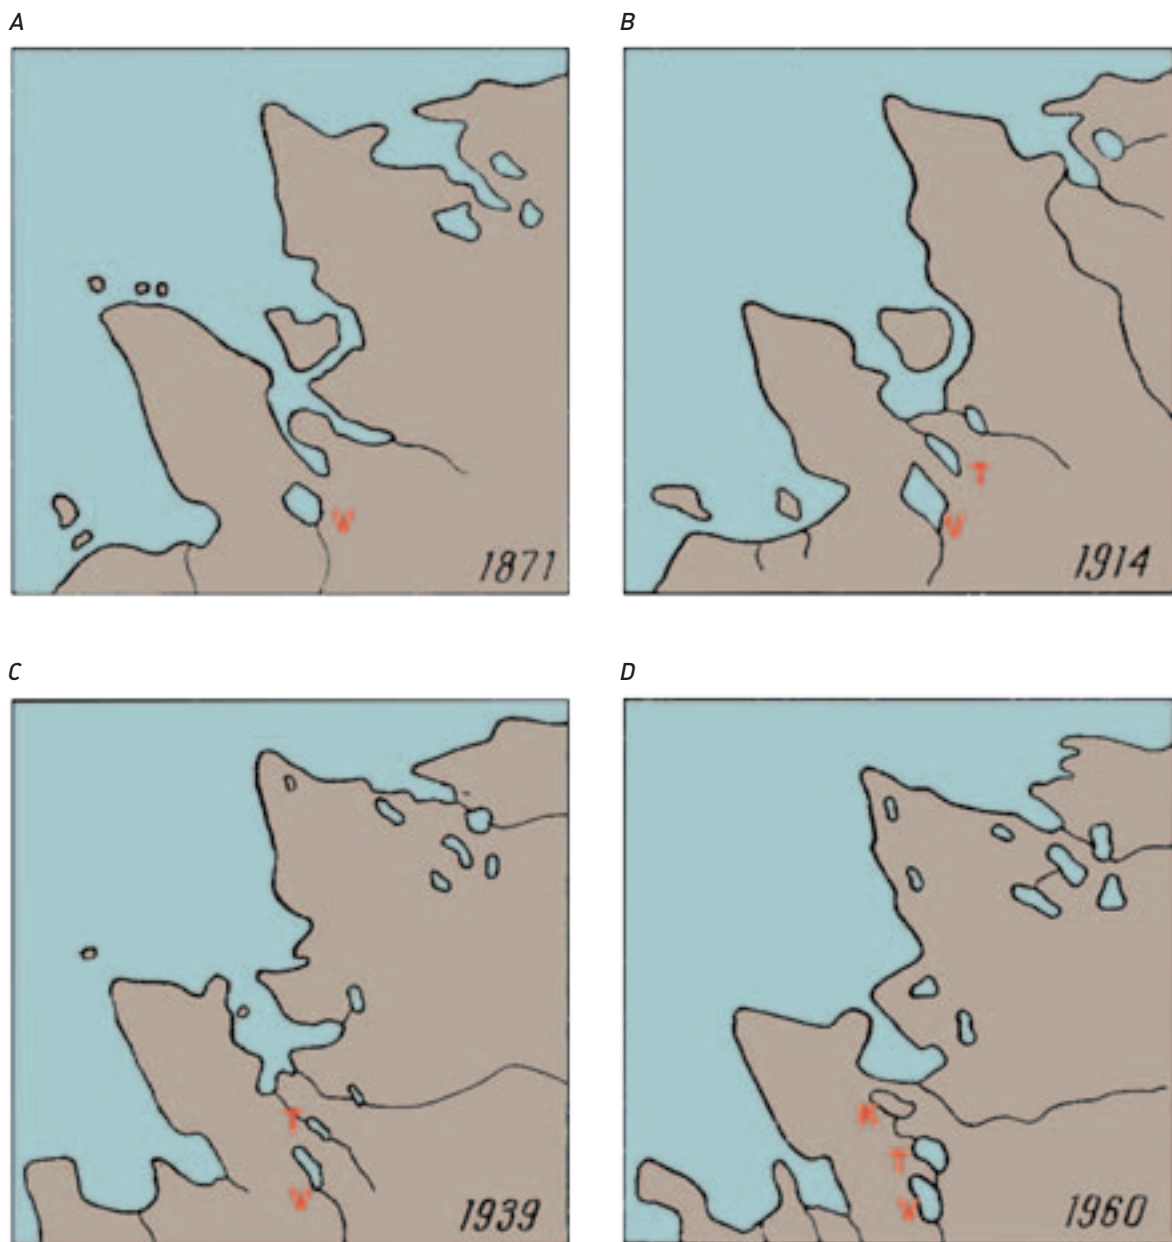
Figure 2.1.1. Changes in the shapes of Hiiumaa coastal lakes 1871–1960. V – Veskilais, T – Tammelais, K – Künaauk.

lakes, for example, are Käina bay, bays of Kirikulaht and Mõisalaht, Undu bay. Coastal lakes change very rapidly (Tamre *et al.*, 2008). Their changing shapes and areas can be well observed on digitalised maps (Figure 2.1.1) and then analysed (Figures 2.1.2, 2.1.3). The maps used are the Russian one-verst map 1891–1921 (1:42,000), the Estonian topographic map 1935–1940 (1:50,000) and the Estonian base map of 2003.

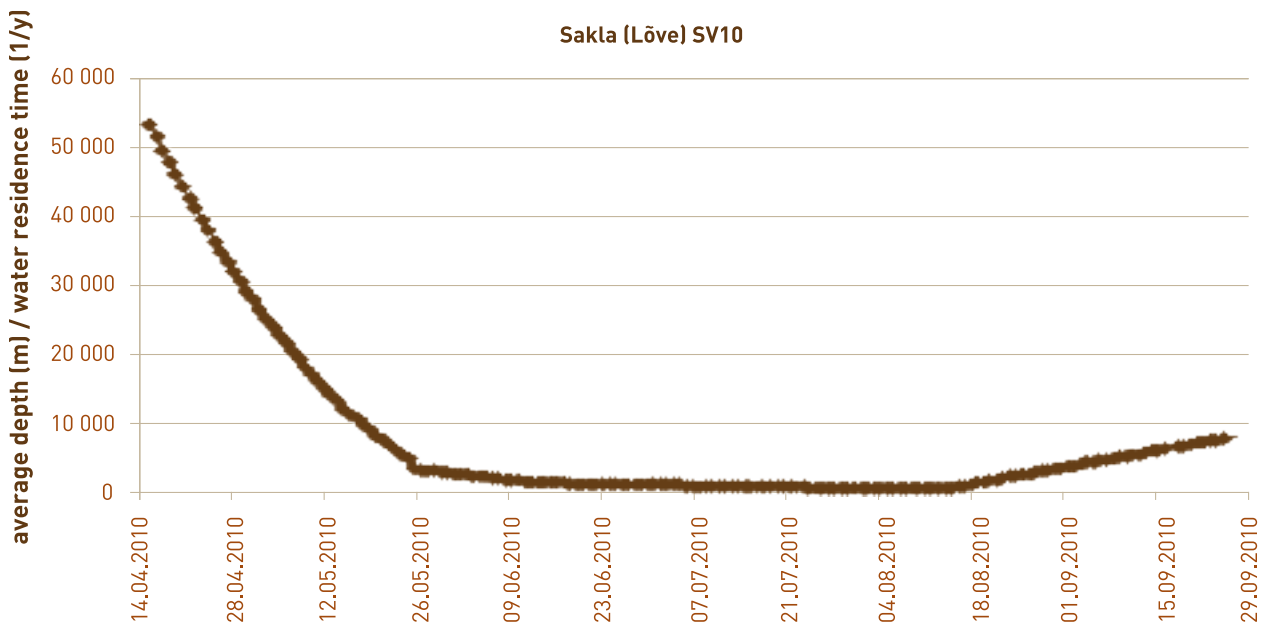
Figure 2.2.1. Dynamics of the P load in River Sakla (Löve) (SV10) 13. IV–29. IX 2010.

The load tolerance of coastal lakes is assessed by phosphorus (P) load, the average depth of the lake and the residence time of the water. According to the methodology of the Vollenweider (1975) model, an annual load should be used in calculations. We can only do it on a shorter period of the time we were studying coastal lakes in 2010 and 2011. Regardless of a shorter time period, it still enables to provide some kind of assessment. Large amount of P flows from the Lõve river to Oessaare bay (Figure 2.2.1). According to the 2011 national monitoring, the ecological condition of Lõve river is poor, which refers to pollution. The residence time of the water in Oessaare bay is only 8 days, according to Loopmann (1984). Based on the Vollenweider model, the load capacity of Oessaare bay is 0.3–0.4 g/m² per year. It is estimated that during that period, the flow amounts make up 70–80% of the annual amount. Considering certain incompleteness of the data, the results on Figure 2.2.2 have been presented as a longer line, not as a point. Such a model cannot be created on all lakes – Laidevahe coastal lagoon is directly connected to the sea, as well as the Aenga lake that has no direct clear inflow; as to Põldealuse, the inflow is difficult to determine. Oessaare bay and Poka bay stand out quite distinctively, the latter suffering from pollution. The situation in Mullutu, Suurlaht and Vägara, however, is much better. Aenga bay is most influenced

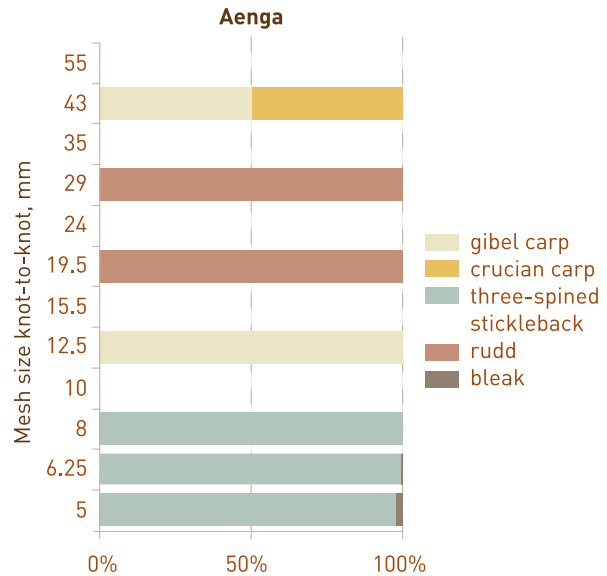
Figure 4.1.1.1. Distribution of fish species into different mesh sizes of a Nordic gillnet (mm) in the Aenga bay sampled in July 2010.

Fish. From Aenga bay, 441 fish of five species was caught with Nordic gillnets: gibel carp, crucian carp, three-spined stickleback, rudd, and bleak (Figure 4.1.1.1). The total mass of the catch was 2.82 kg. The most numerous species was three-spined stickleback that was caught in masses by the mesh of the size 6.25–10 mm knot-to-knot. Gibel carp was represented in this coastal lake by several generations. A crucian carp with a length of 27.5 cm, weight of 401.6 g and age of 9 years was caught from the lake.

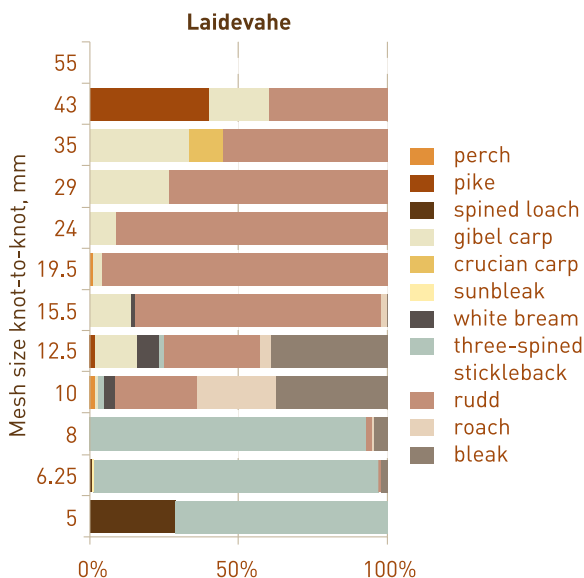
Figure 4.1.2.1 Distribution of fish species into different mesh sizes of a Nordic gillnet (mm) in the Laidevahe bay sampled in July 2010.

Fish. Two lines of nets were used in Laidevahe bay (12 Nordic gillnets), and 11 fish species were caught (Figure 4.1.2.1) The total catch was 19.8 kg, in total 2,580 specimen. The most numerous species was three-spined stickleback with 2,044 specimen (most of them caught by the mesh size of 10 mm knot-to-knot). Almost all sections of the net captured rudd (mesh panels of 6.25–43 mm knot-to-knot). Rudds were mainly 10–17 cm in length. Bleak was also a numerous species, caught by mesh of 6.25–12.5 mm knot-to-knot, as usual. Four summers-of-age gibel carp was the most copious in Laidevahe. Of endangered species, spined loach was represented only in Laidevahe (seven specimen), not captured in any of the other studied lakes. Of predatory fish, pike was caught.

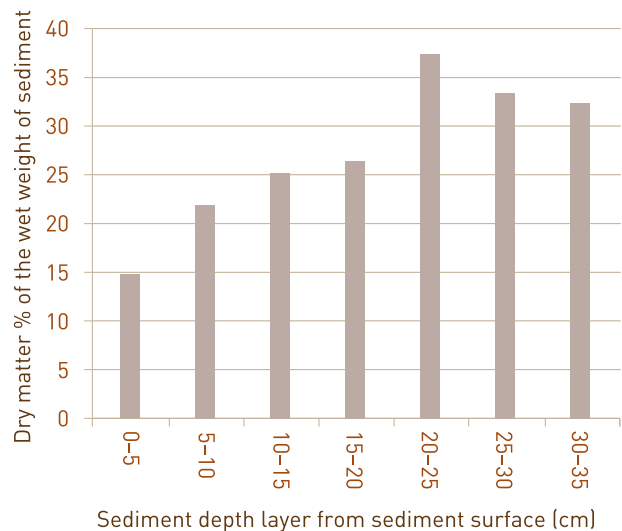
Figure 4.1.5.2. Dry matter content of Oessaare bay sediment.

Sediments. In Oessaare bay, near the inflow, only 25 cm into the sediment could be drilled. The upper 5 cm of it was formed by a very fluid greenish mud, followed by 15 cm of loose mud with carp remnants, then 10 cm of gravelly mud and underneath it, thick sandy clayey-gravelly sediment and large cobblestones. In other areas, the mud layer has reduced, the sediment turns quickly into sandy clay. Dry matter content in the Oessaare sediment was 14.7% in the upper layer, and a maximum of 37.3% (Figure 4.1.5.2) in the bottom layers of a 35 cm sediment tube, that is a lot thicker than in Linnulaht.

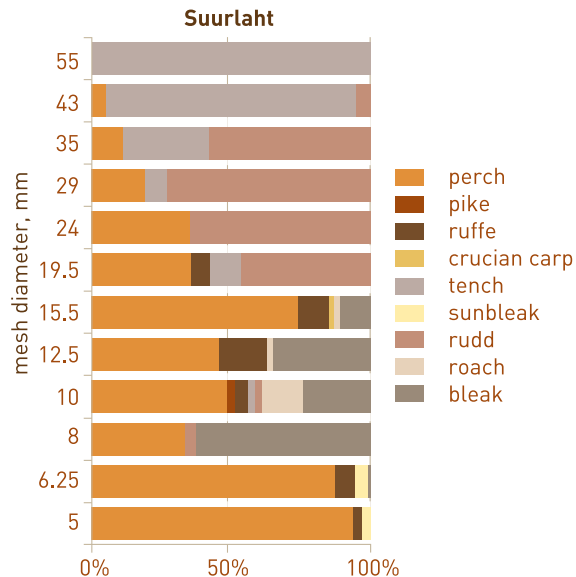
Figure 4.1.8.1. Distribution of fish species into different mesh sizes of a section net (mm) in the Suurlaht bay test catches in July 2010.

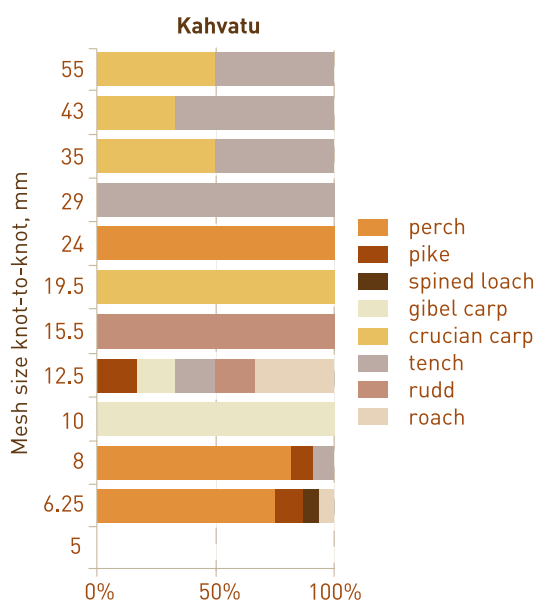
Figure 4.2.1.1. Distribution of species among the different mesh sizes of a Nordic gillnet in Kahvatu bay in July 2011.

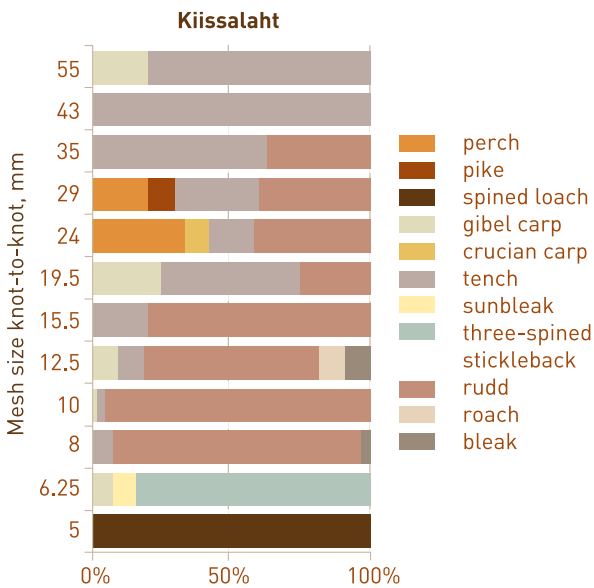
Figure 4.2.3.1. Distribution of species among the different mesh sizes of a Nordic gillnet in Kiissalaht in July 2011.

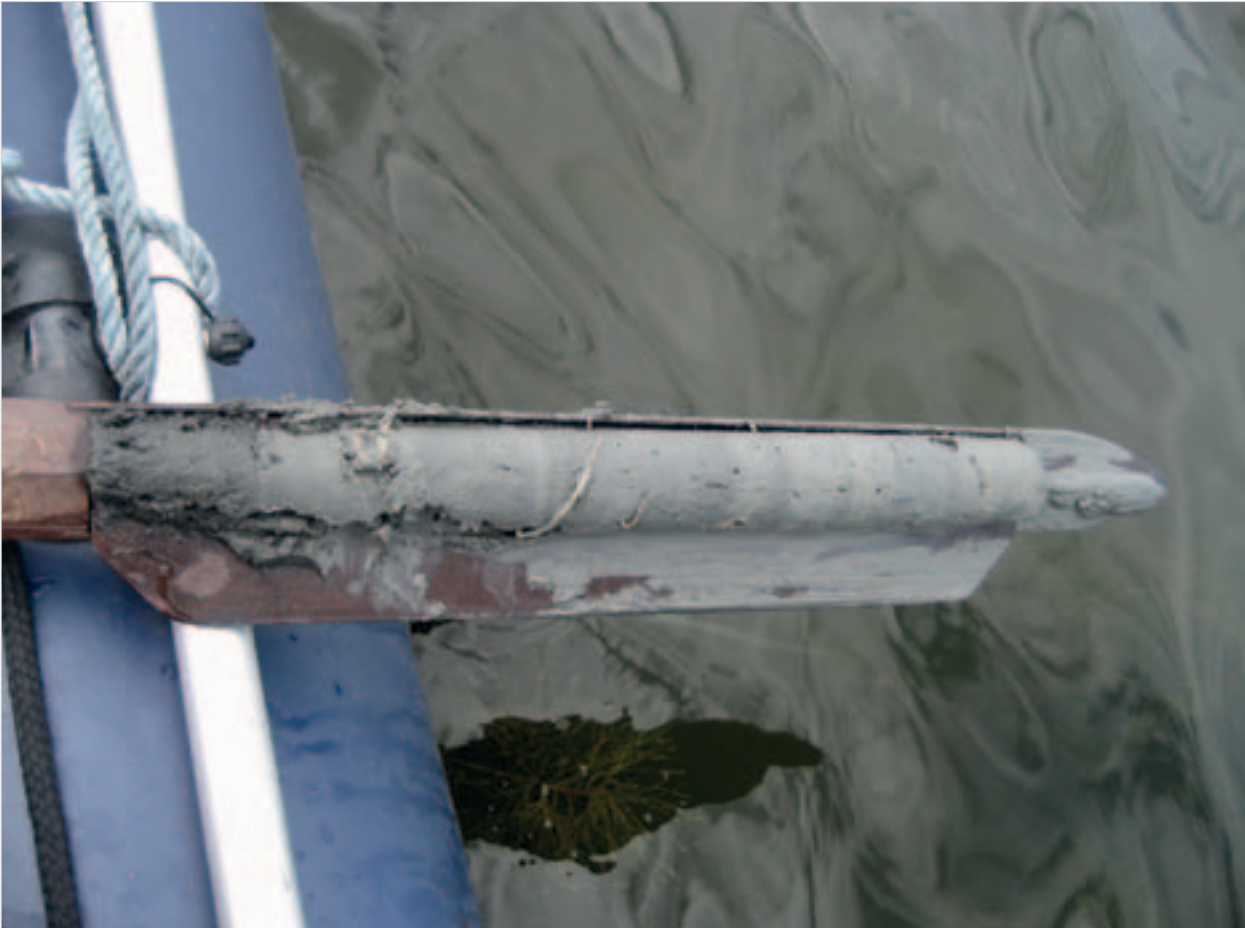
Photo 4.2.7.1. Sediment core from the Vööla meri. The sediment drill core is 50 cm long. Dark grey mud on the surface, followed by silt and in the bottom of the core by silt clay.

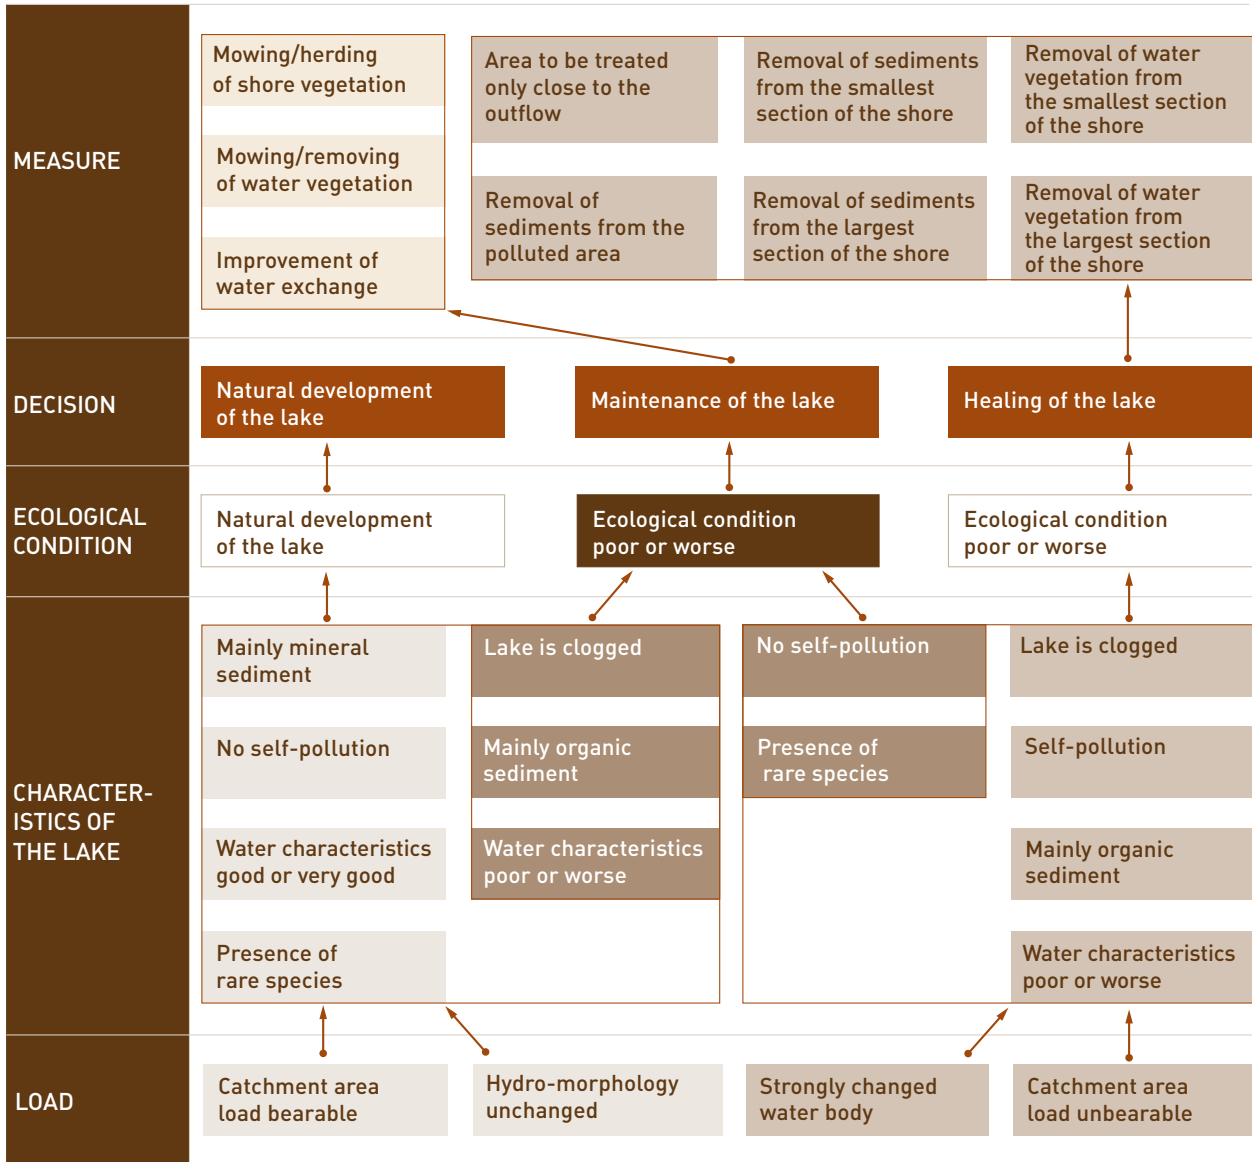
Figure 5.2.3.1. Scheme on the need to maintain or heal coastal lagoons based on different base conditions of environmental condition and the conservation objectives. Compiled by Ingmar Ott.

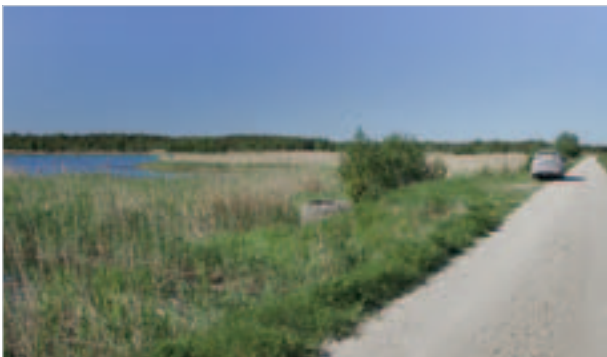
Photo 5.2.3.1. The water exchange of Vööla coastal lake with the sea is prevented by a road built on the coast. The water management plan of the area has assessed the ecological condition of the lake as bad.

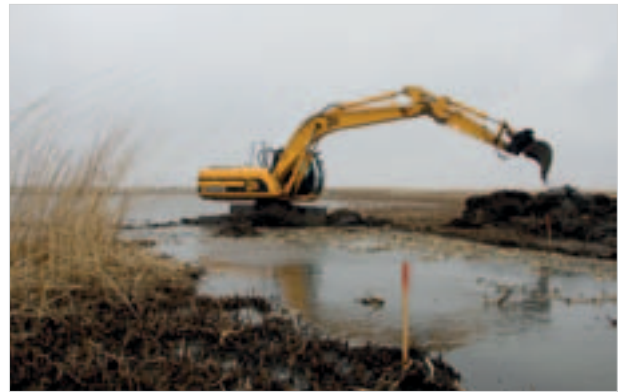
Photo 6.1.5. Restoration of a sea connection channel of a coastal lagoon with a digger

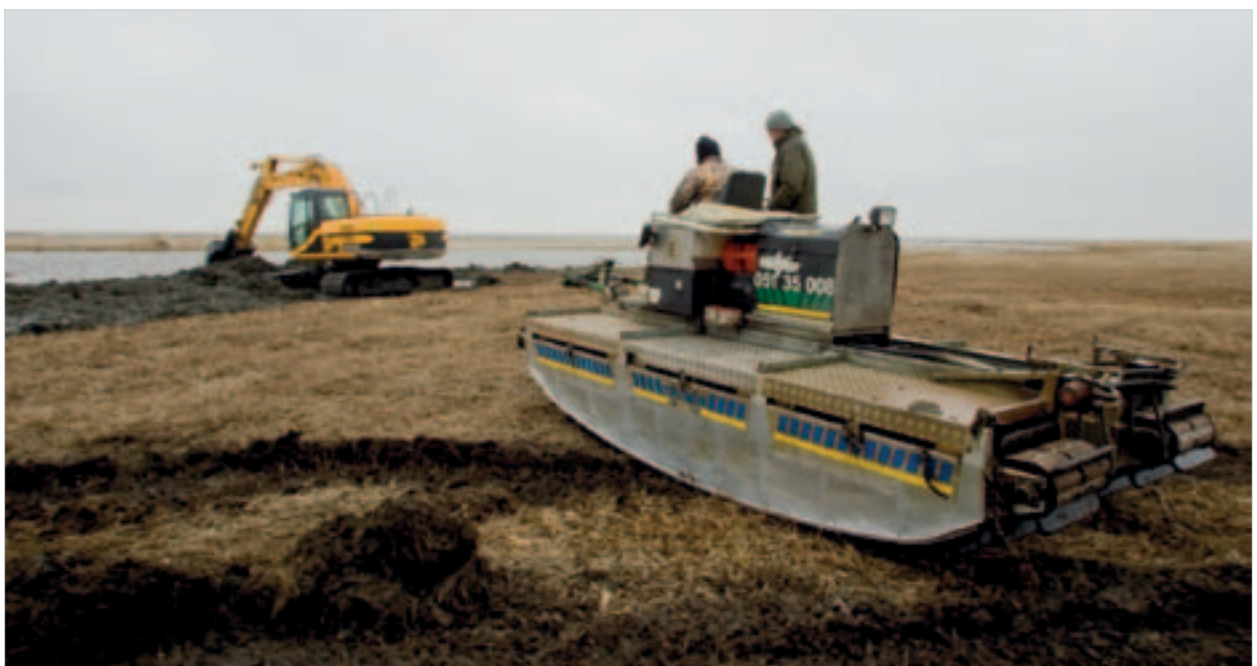
Photo 6.1.6. Spreading of the sediments and plant parts removed from the lagoons to the shores (on the background). On the foreground, a Truxor amphibian tractor.

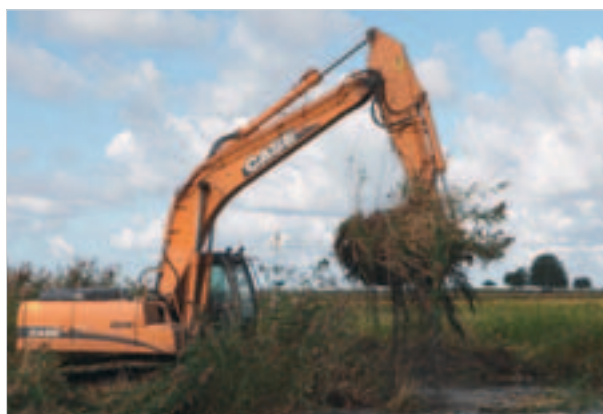
Photo 6.1.8. Removal of reed and its thick rhizome layer with a digger from the northern shore of the large lagoon of Vöiste in 2009.
